RESIDENTIAL BUILDING REPORT

34 Raleigh St
WINDSOR

Report Prepared: 2 August 2013

PRE-PURCHASE INSPECTION RESIDENTIAL BUILDING REPORT

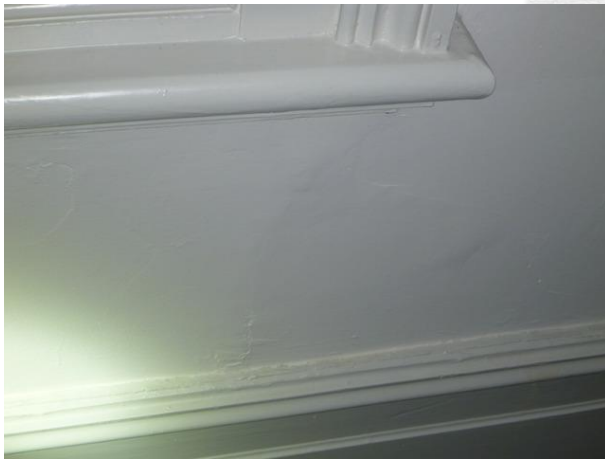
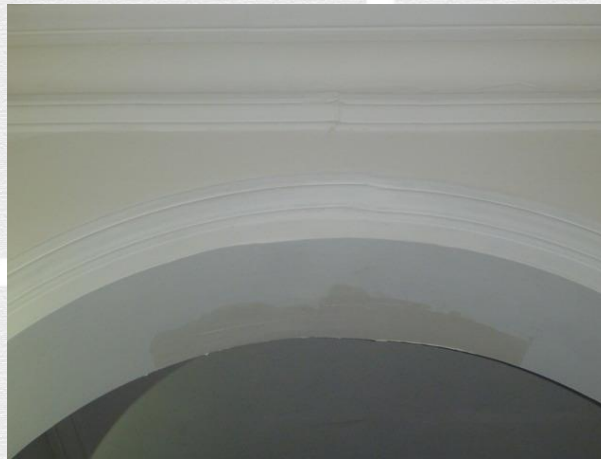
b) Walls			
	Material deterioration	<ul style="list-style-type: none"> • Location: Throughout • Major defect 	<ul style="list-style-type: none"> • There is unprofessional patching and finishing (below standard workmanship) of the wall coverings. This patching appears to be over previous wall cracking due to movement in the footings or a lack of expansion joints in the brickwork. Initially it is suggested that a "Licensed Plasterer" be contacted for further evaluation and repair. If cracking re-appears then seek the advice of a qualified bricklayer and/or a structural engineer.

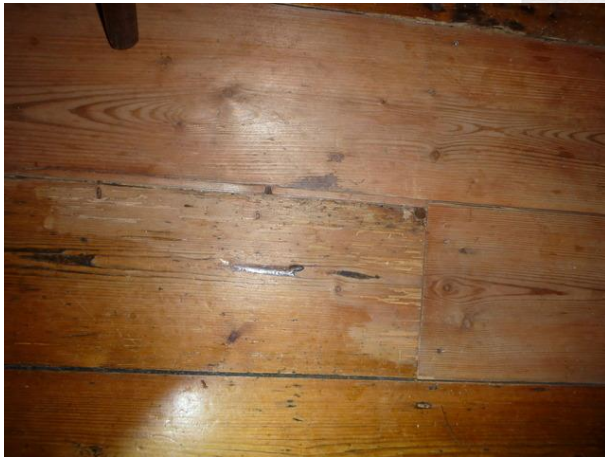
c) Timber Floors			
	Material deterioration	<ul style="list-style-type: none"> • Major defect • Location: Throughout • Location: Kitchen • Minor defect 	<ul style="list-style-type: none"> • There is significant sloping and unevenness in the timber flooring indicating that the timber subfloor (bearers, joists and stumps) need to be rectified and/or re-levelled (restumped). It is recommended that you seek the advice from a qualified carpenter or restumper/reblocker to determine level of rectification required. • There is evidence of timber pest activity (borer- Furniture Beetle) and/or damage present throughout the timber flooring. There are a number of timber boards throughout the house interior that need to be replaced by a qualified carpenter. It is also recommended that a certified pest controller undertake a form of 'pest control' to prevent further more significant damage occurring in the future.

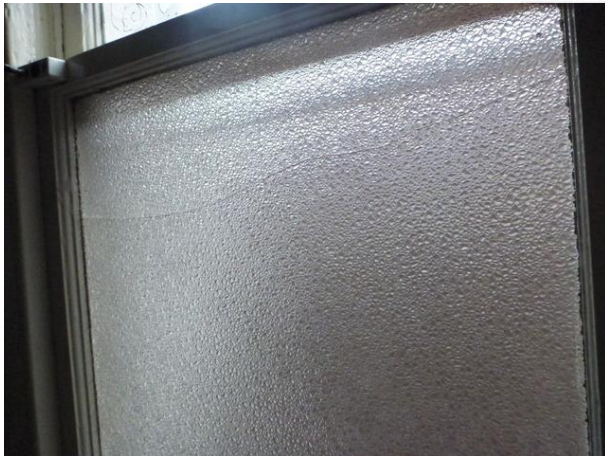
l) Windows			
	Material deterioration	<ul style="list-style-type: none"> Minor defect 	<ul style="list-style-type: none"> There is a cracked windowpane. This needs to be replaced by a qualified glazier.

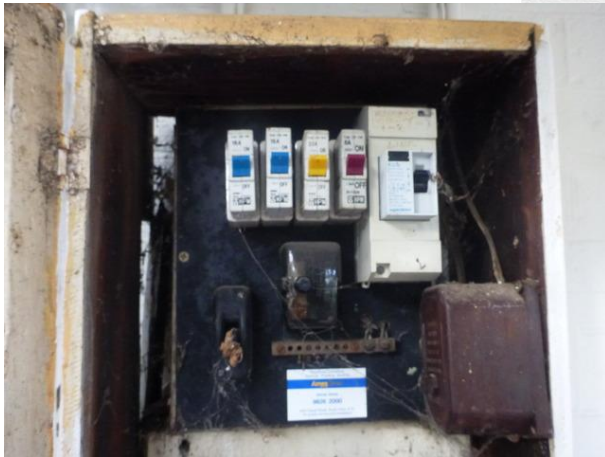
1.5 Electrical Installation	<i>All electrical wiring, meter boxes and appliances need to be checked by a qualified electrician. The checking of any electrical item is outside the scope of this inspection</i>		<i>*It is recommended that a licensed electrician be consulted for further advice</i>
1.6 Plumbing	<i>All plumbing needs to be inspected and reported on by a plumber</i>		<i>*Its recommended that a licensed plumber be consulted for further advice</i>
1.7 Smoke Detectors			
		<ul style="list-style-type: none"> Location: None 	<i>AS 3786 – Advises that Smoke detectors are required for all buildings where people sleep. It is recommended that an electrician be consulted to advise on those installed or install these detectors.</i>

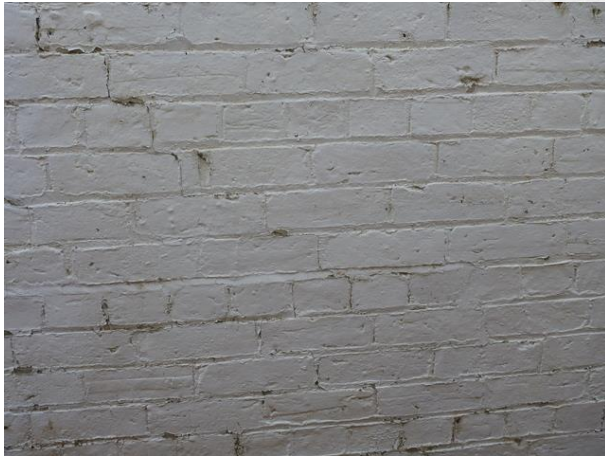
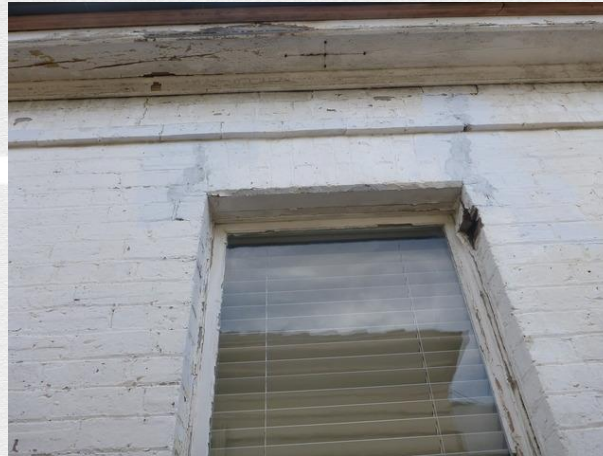
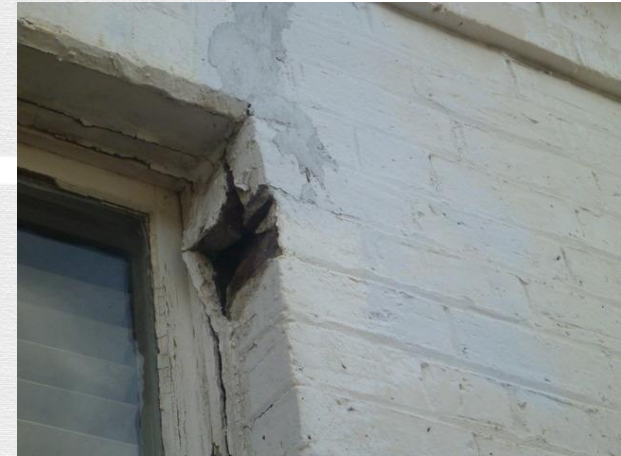
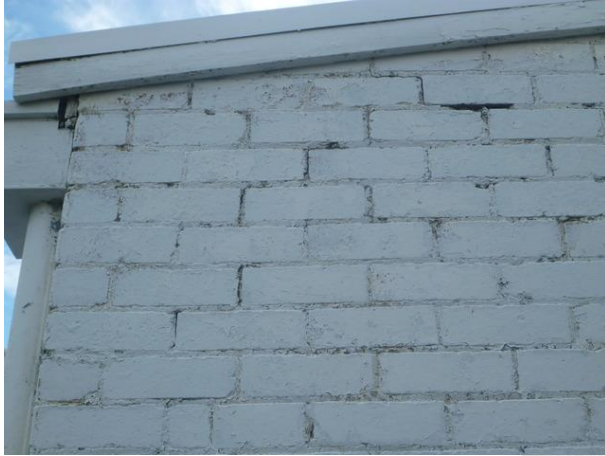
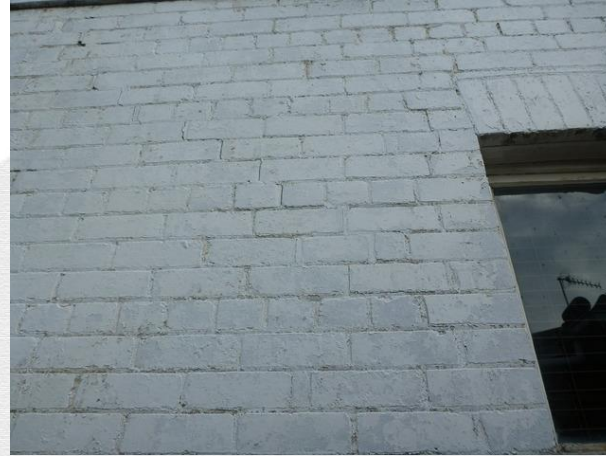
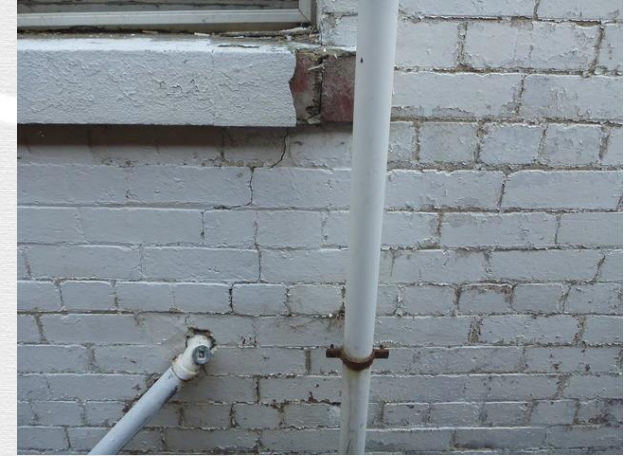
a) Walls Exterior			
	Material deterioration	<ul style="list-style-type: none"> Location: Western, southern and eastern walls Major defect 	<ul style="list-style-type: none"> There is movement cracking in the exterior masonry. This cracking may have been caused by lintel movement/deterioration above the windows/doors or a lack of expansion joints present throughout the brickwork. This cracking needs to be closely monitored and sections of the brickwork may need to be replaced by a qualified bricklayer in the short term. Regardless of the appearance of the cracks a Pre Purchase Building Inspector carrying out a Pre Purchase Inspection within the scope of a visual inspection is unable to determine the expected consequences of the cracks. Obtaining Information regarding: <ul style="list-style-type: none"> (a) The nature of the foundation material on which the building is resting, (b) The design of the footings, (c) The site landscape, (d) The history of the cracks and (e) Carrying out an invasive inspection, all fall outside the scope of this Pre purchase inspection. However the information obtained from the five items above are valuable, in determining the expected consequences of the cracking and any remedial work needed. Cracks that are small in width and length on the day of the inspection may have the potential to develop over time into Structural Problems for the Home Owner resulting in major expensive rectification work been carried out. There are no expansion joints in the brickwork. Expansion joints

<ul style="list-style-type: none"> • Location: Throughout • Minor defect 	<p>allow for minor movement to occur in walls in a controlled manner while also reducing the likelihood of cracking. It is recommended that you seek the advice of a structural engineer and qualified bricklayer to determine if expansion joints would be a suitable and achievable solution to the cracking.</p> <ul style="list-style-type: none"> • There are sections throughout the brickwork that have been patched. This may have been due to previous cracking, replacement/removal of a window/old air conditioning unit/old pipe penetration or door. This area needs to be closely monitored. If cracking, movement or deterioration occurs then we recommend that you seek the advice of a structural engineer and qualified bricklayer.
--	--	--	---

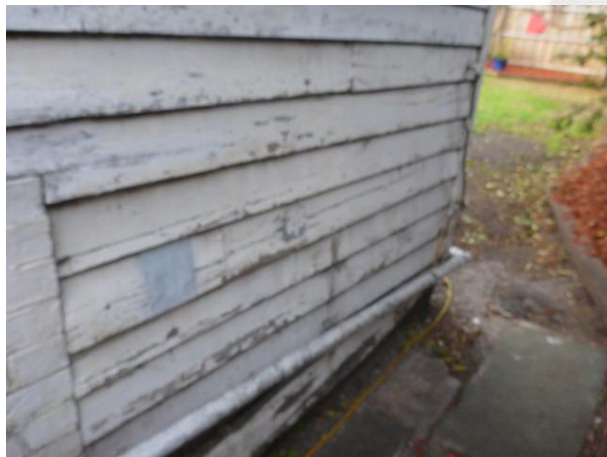
b) External Cladding			
	Material deterioration	<ul style="list-style-type: none"> Location: Western wall Minor defect 	<ul style="list-style-type: none"> There are signs of rot and deterioration throughout the external cladding (weatherboards). It is strongly recommended that the affected weatherboard cladding be painted and sections replaced by a qualified painter and carpenter. This should be done to ensure further rot doesn't occur.

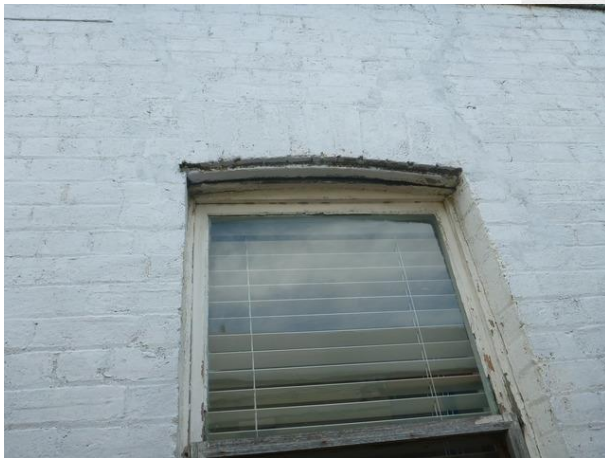
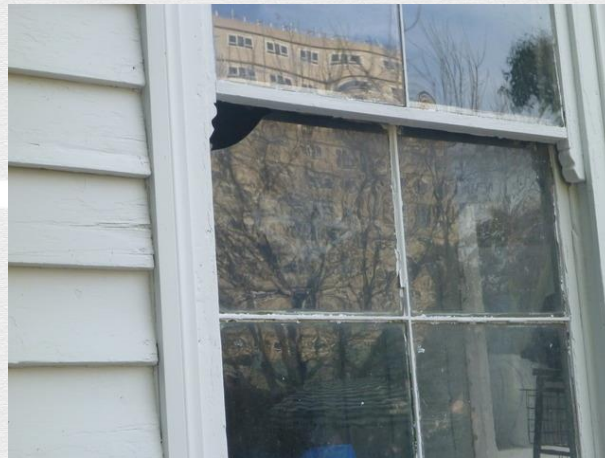
g) Exterior Doors & Door Frames			
	No significant defects		<ul style="list-style-type: none"> The doors appeared to be in serviceable condition at the time of the inspection.
h) Windows			
	Material deterioration	<ul style="list-style-type: none"> Location: Throughout western and eastern windows Minor defect Location: Laundry window Minor defect 	<ul style="list-style-type: none"> A number of windows are aging and deterioration is present. These windows and window jambs/frames need to be urgently rectified by a qualified painter. The timber needs to be sanded right back (remove rotting areas) and appropriately filled and sealed to remove any further more significant rotting and deterioration occurring. There is a cracked windowpane. This needs to be replaced by a qualified glazier.

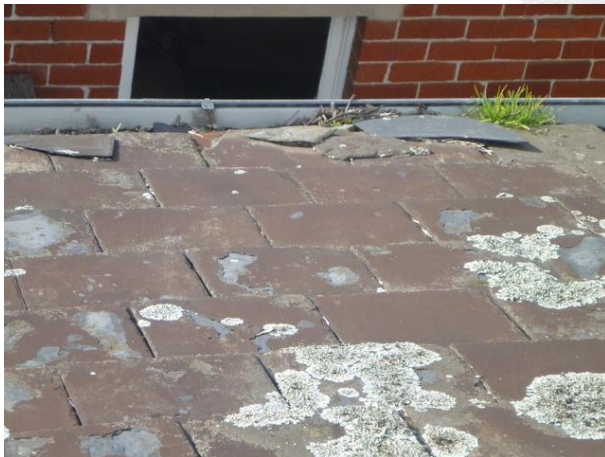
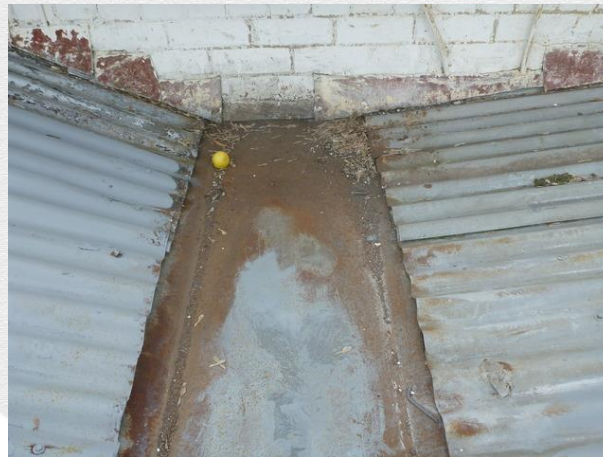
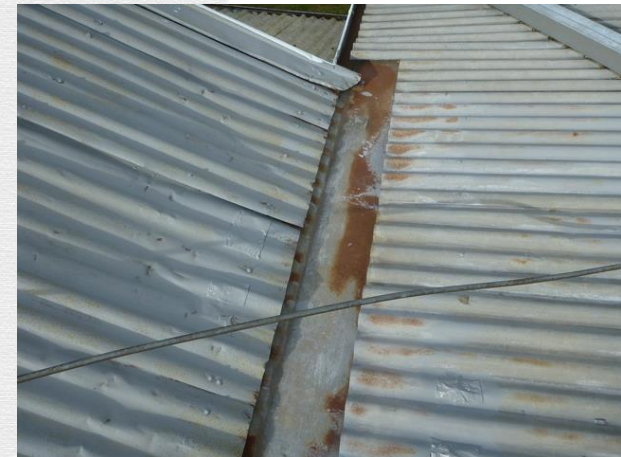
c) Gutters			
	Material deterioration	<ul style="list-style-type: none"> • Location: Throughout • Minor defect 	<ul style="list-style-type: none"> • There is early stages of rusting throughout the guttering system that needs to be sealed with a non-corrosive product. It is recommended that this be undertaken by a qualified painter to prevent further more significant rusting occurring and potential replacement.
		<ul style="list-style-type: none"> • Location: Throughout box gutters and southern gutters • Major defect 	<ul style="list-style-type: none"> • There is significant rusting throughout the guttering system that needs to be replaced in the short to medium term. This needs to be undertaken by a qualified roof plumber to enable storm water to escape freely and easily while preventing potential water entering the ceiling/house interior or build up at the base of walls and in the subfloor.

<ul style="list-style-type: none"> • Location: Eastern and northern gutters • Minor defect 	<ul style="list-style-type: none"> • The gutters were filled with leaves and debris at the time of the inspection. It is essential that cleaning and removal of debris be immediately undertaken and on a regular basis. This condition can cause water build up and water damage throughout the roof interior and ceiling.

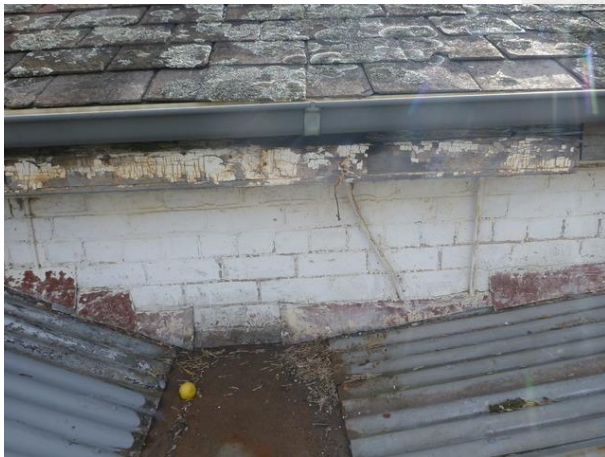
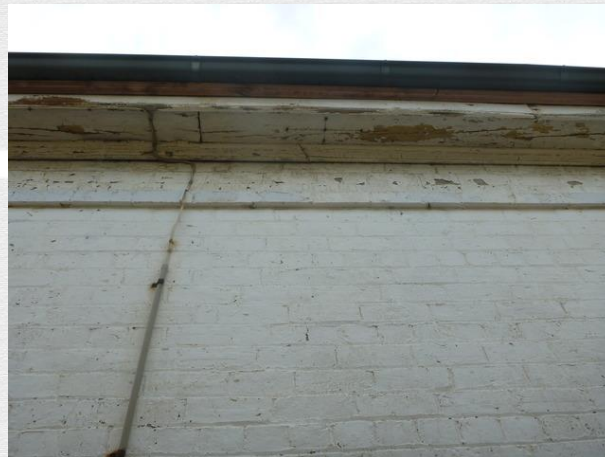
d) Downpipes			
	No significant defects		<ul style="list-style-type: none"> The downpipe system appeared to be in serviceable condition at the time of the inspection.
e) Eaves Fascia Barges			
	Material deterioration	<ul style="list-style-type: none"> Location: Throughout Minor defect Location: Throughout Minor defect 	<ul style="list-style-type: none"> The fascia boards are in poor condition as rot and deterioration is present. It is suggested that a "Licensed Builder/ Carpenter and Painter" be contacted for further evaluation and repair. There is evidence of the timber eaves rotting due to moisture build up from the gutters and/or cracked tiles. These sections need to be rectified by a qualified roof plumber to prevent further rot and deterioration occurring in the future, by rectifying the problem area. Also these affected rotted eaves need to be patched by a qualified painter.

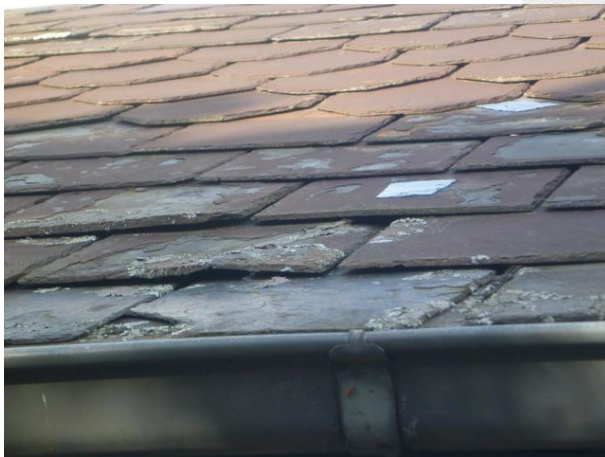
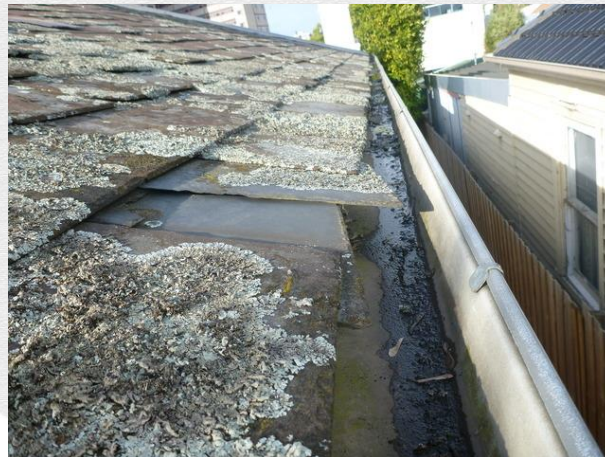
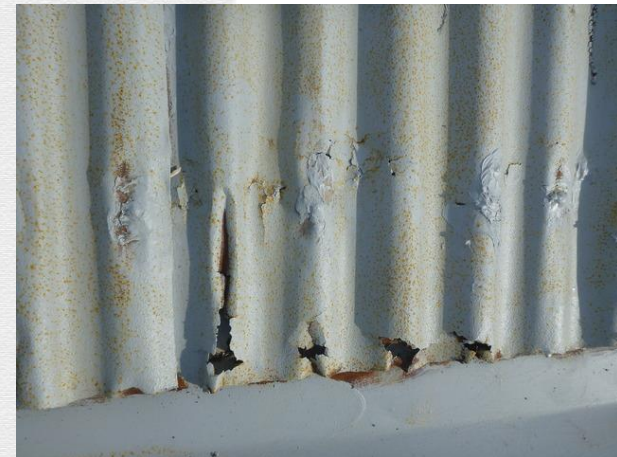
g) Roof Covering			
	Material deterioration	<ul style="list-style-type: none"> • Location: Throughout slate roof • Minor defect 	<ul style="list-style-type: none"> • The roof had evidence of unprofessional patching and repair. Given this condition, it is likely that the roof has leaked at one time. It is recommend further evaluation by a qualified roofing contractor. The inspector cannot offer an opinion as to whether the roof leaks today unless it is moderately raining at the time of inspection. Client should obtain full disclosure / history information from the vendor prior to close.
		<ul style="list-style-type: none"> • Location: Throughout • Major defect 	<ul style="list-style-type: none"> • There is significant patching and rusting present throughout the metal sheet roof coverings. These coverings will need to be replaced in the short to medium term by a qualified roof plumber to prevent moisture entering the roof interior causing damage throughout.

<ul style="list-style-type: none"> • Location: Northern slate roof • Minor defect 	<ul style="list-style-type: none"> • There are loose roof slates located throughout the roof covering. These will need to be refitted by a qualified roof tiler to ensure moisture/water doesn't enter the roof interior causing damage.

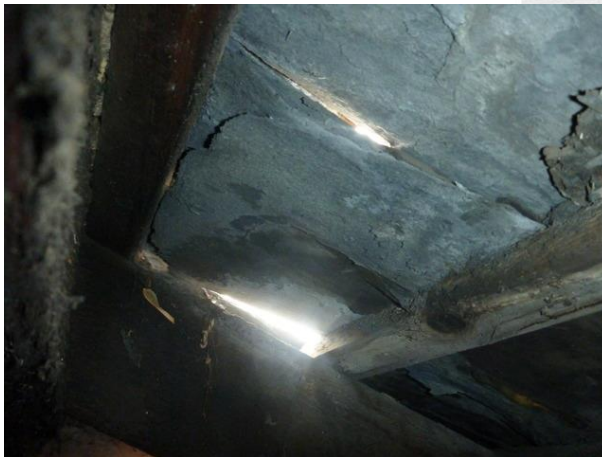
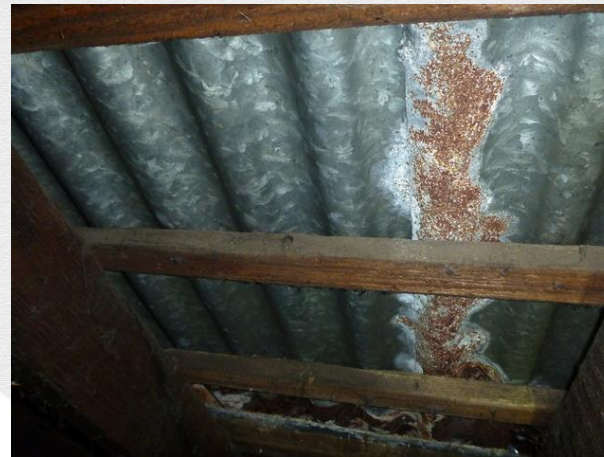
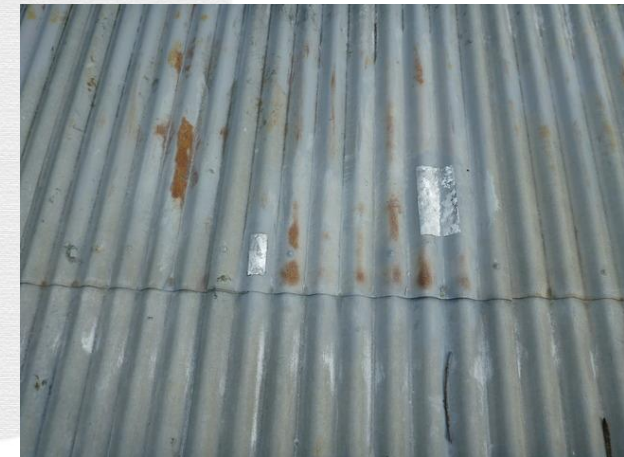
b) Underside of Roof Covering			
	Material deterioration	<ul style="list-style-type: none"> Location: Throughout Major defect Location: Southern metal roof Major defect 	<ul style="list-style-type: none"> There are loose and deteriorated slates located throughout the roof covering. These will need to be replaced by a qualified roof tiler to ensure moisture/water doesn't enter the roof interior causing damage. There is significant rusting present throughout the metal sheet roof coverings. These coverings will need to be replaced in the short to medium term by a qualified roof plumber to prevent moisture entering the roof interior causing damage throughout the roof interior.

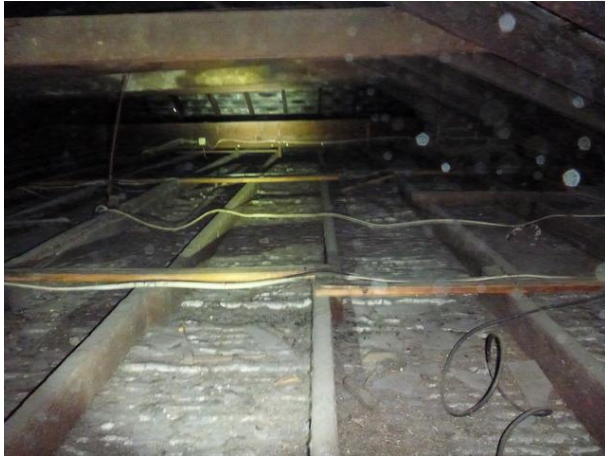
c) Insulation			
	Installation	<ul style="list-style-type: none"> Minor defect 	<ul style="list-style-type: none"> There is no insulation present. It is strongly recommended that insulation be installed by a certified insulation installer to improve the thermal properties of the house.

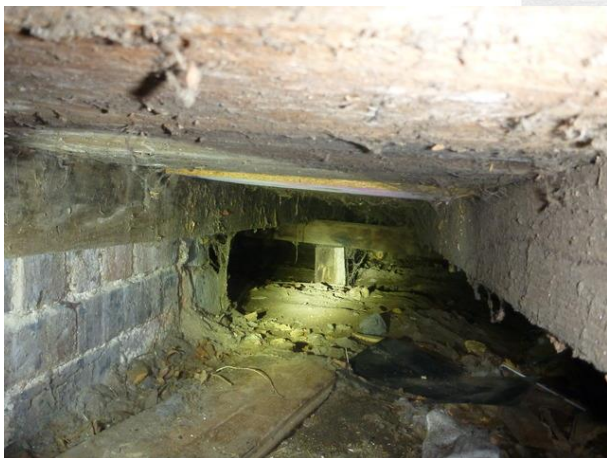
Unable to inspect as there is no suitable access and/or crawlspace. The subfloor was only able to be viewed from the perimeter.

c) Piers, Posts, Supports			
	Unable to inspect as there is no suitable access

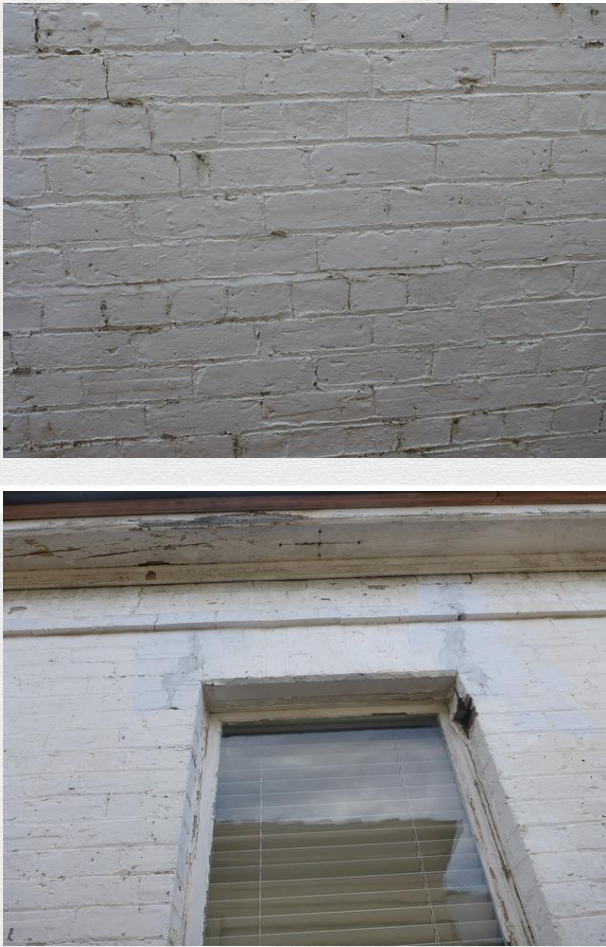
Where is the cracked Area?	Detailed Photo of Crack	Width and Length of Crack
Western exterior wall

<ul style="list-style-type: none">• Location: Throughout western wall• Width: 1-2mm• Length: 2000-3000mm

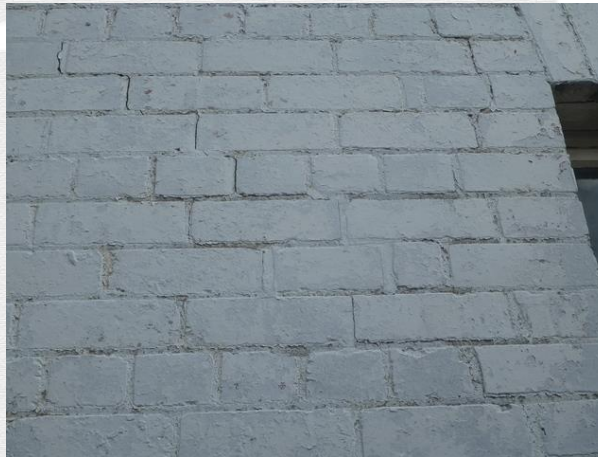
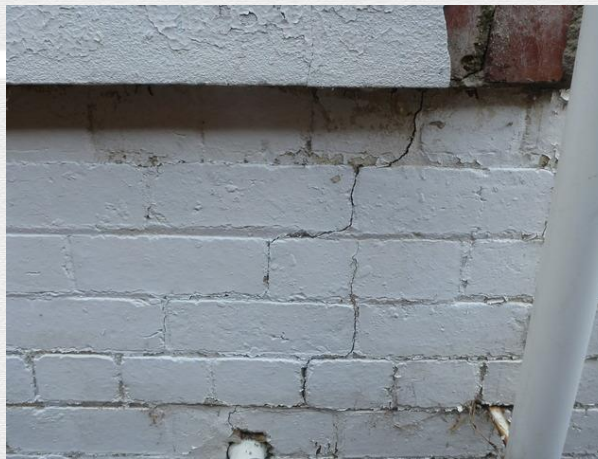
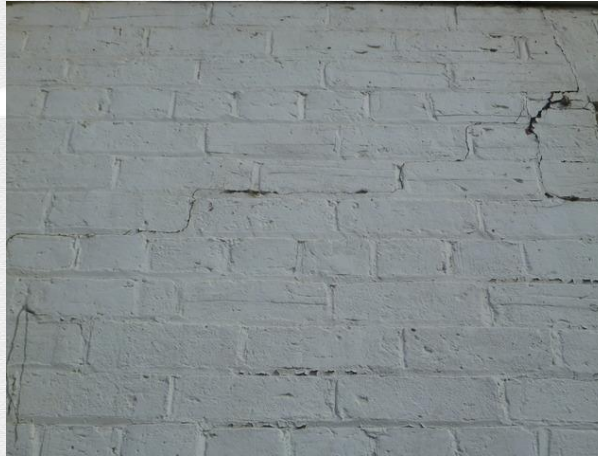
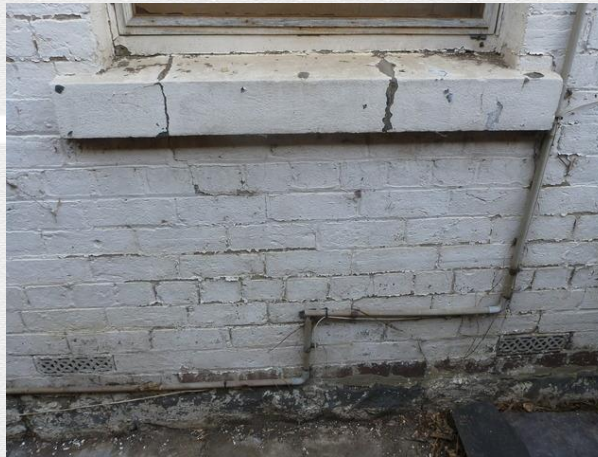
Eastern exterior wall

- Location: Eastern wall
- Width: 1-3mm
- Length: 2000-3000mm

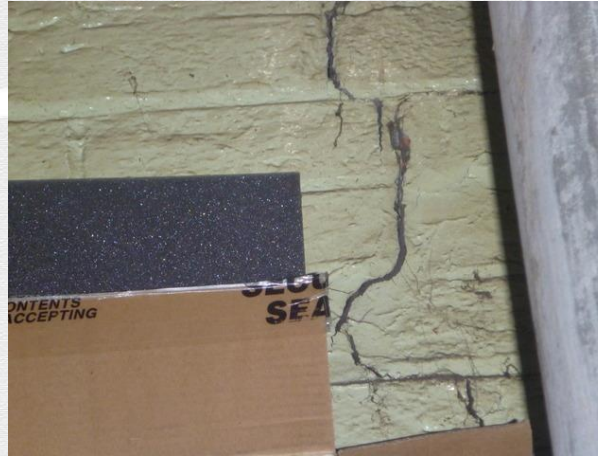
Southern exterior wall
(located in the add on laundry)

- Location: Southern wall
- Width: 2-5mm
- Length: 500-1000mm
