## Sample / Building Inspection Report

125 Burke Drive, Monroeville, Pennsylvania 15146

**Inspection date:**  
02-20-06

**Report Number:**  
4370

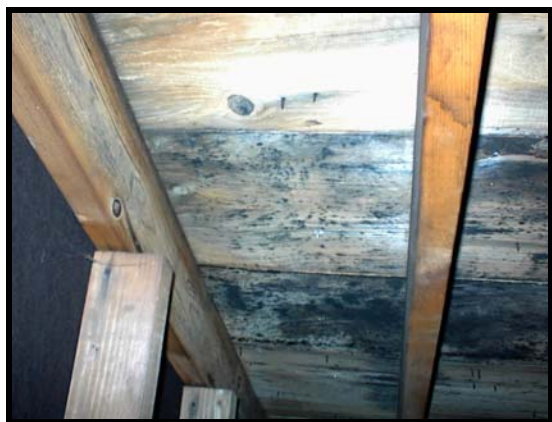
**IMPROVE / REPAIR / CORRECT** material defect; the presence of fungal matter (i.e. mold) was noted within the attic space at both framing (i.e. rafters) and plank decking (i.e. roof) boards.

*The mere presence of mold would indicate inadequate ventilation, excessive moisture-laden air or a combination of both.*

- Operation of the furnace humidifier at too high of a level.
- Bathroom exhaust vents(s) improperly discharging into the attic space.

- Soffit vents partially blocked with insulation
- Power-vent fan inoperative (i.e. motor seized)

- The installation of additional soffit ventilation. Baffles should be installed to hold back the insulation and allow for movement of air through the soffit vents and into the attic space.
- The installation of a ridge vent.

- Replacing existing power-vent fan (i.e. which is not working) with a new fan that operates off both a humidistat and temperature control.
- Reduce moisture-laden air at living space; be careful so as not to operate humidifier at levels which exceed recommended standards.
- Install an exhaust fan (i.e. vented to the exterior) to service the main bathroom.

- Improve ventilation
- Contact a professional to discuss testing and remediation of fungal matter (i.e. mold condition).

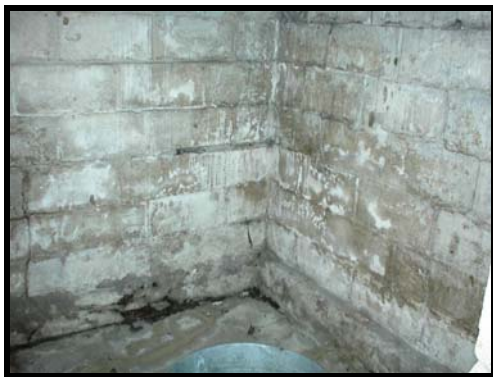
**IMPROVE / REPAIR / CORRECT**; active moisture intrusion and/or condition(s) which indicate same were apparent at the left front corner area of the basement.

*Moisture penetration at the left front corner area of the basement*

*Corrections are recommended; client is advised to seek professional advice from a "basement waterproofing contractor" regarding this matter.*

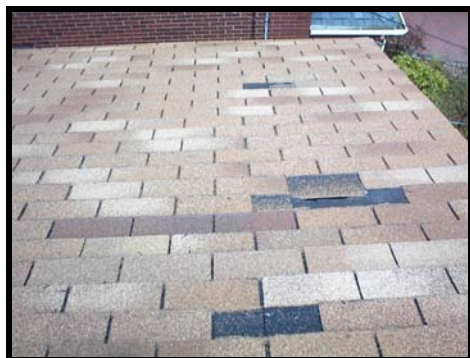
**IMPROVE / REPAIR / CORRECT**; wind damage including missing and/or torn shingles were observed at the rear slope. Client is advised to consult with a roofing contractor regarding needed repairs.

*Missing and/or damaged shingles at the rear slope*

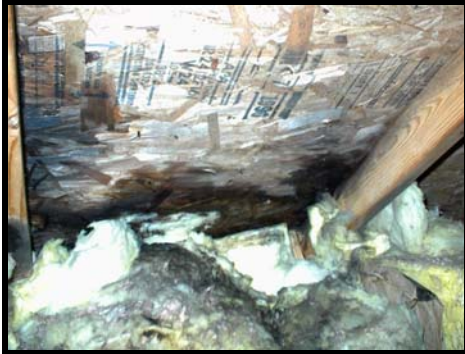
**IMPROVE / REPAIR / CORRECT**; active leakage was noted at or adjacent to the skylight at the rear addition. The photo below depicts the leakage as viewed from within the attic space. The leakage appears to be due to a flashing deficiency. This condition should be further evaluated for repair by a qualified roofing contractor.

*Leakage at skylight as viewed from the attic space.*
